A E G I S

Distribution of Closed GL Financial Claims Reported

Gas Utilities 1975-2012

Complacency, Short-Cuts-Failure to Follow Procedures

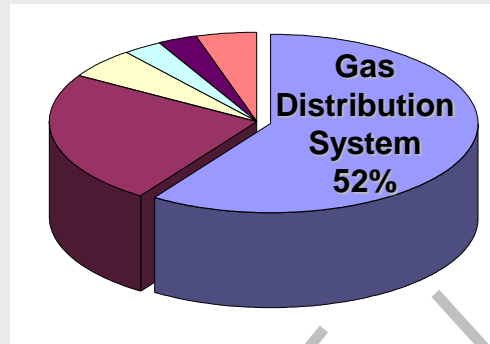
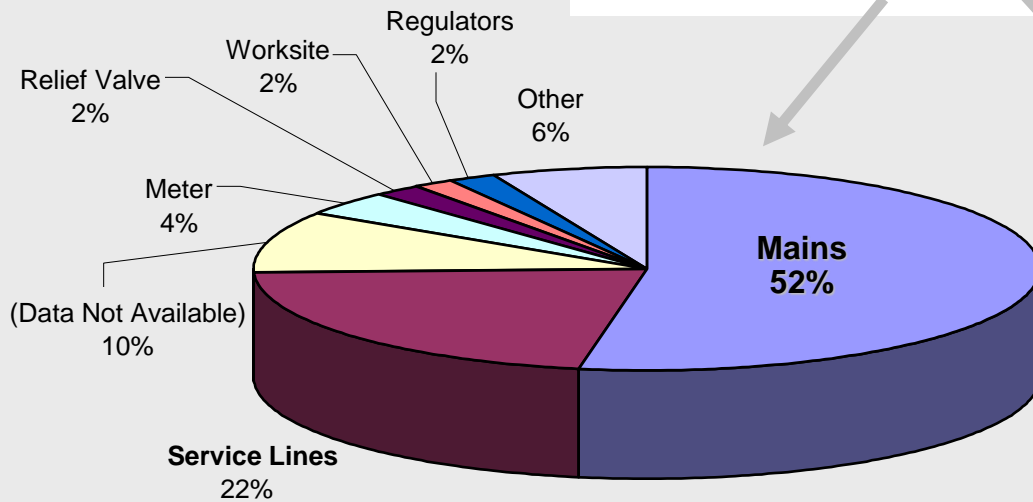
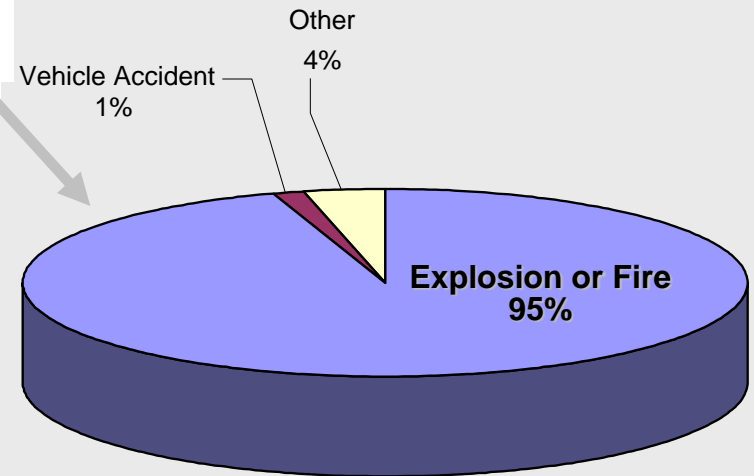
Gas Distribution System

Types of Losses and Components Affected

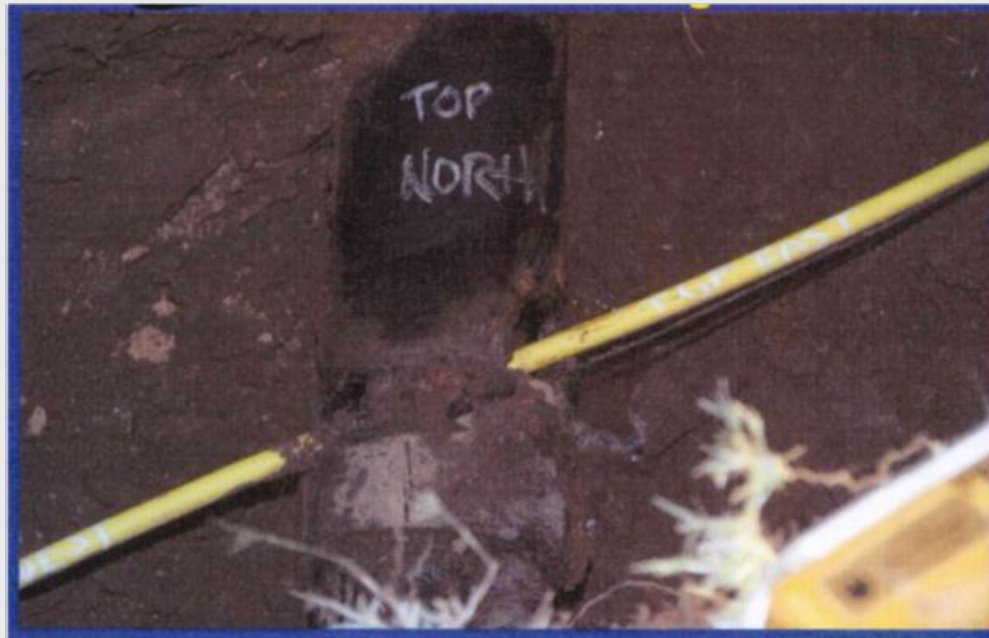
Gas Explosion

Mobile Home Destroyed, 3 Injured

A utility was installing gas lines at a mobile home park. While boring underground to install polyethylene gas pipes, employees drilled through the sewer lateral.

- Experience is good but could be a double edge sword
- “It can’t happen to me” syndrome
- Field visits and safety audits can’t be replaced
- Take corrective action
- Lead by example

- Training programs, safety meetings and peer supervisory reviews are a few of the options that can be utilized to ensure established work practices are followed, thereby reducing the hazards associated with using shortcuts or allowing complacency to interfere with good judgment.
- Field visits on a frequent basis
- We must **NEVER** lose respect for natural gas.
- Complacency can kill.

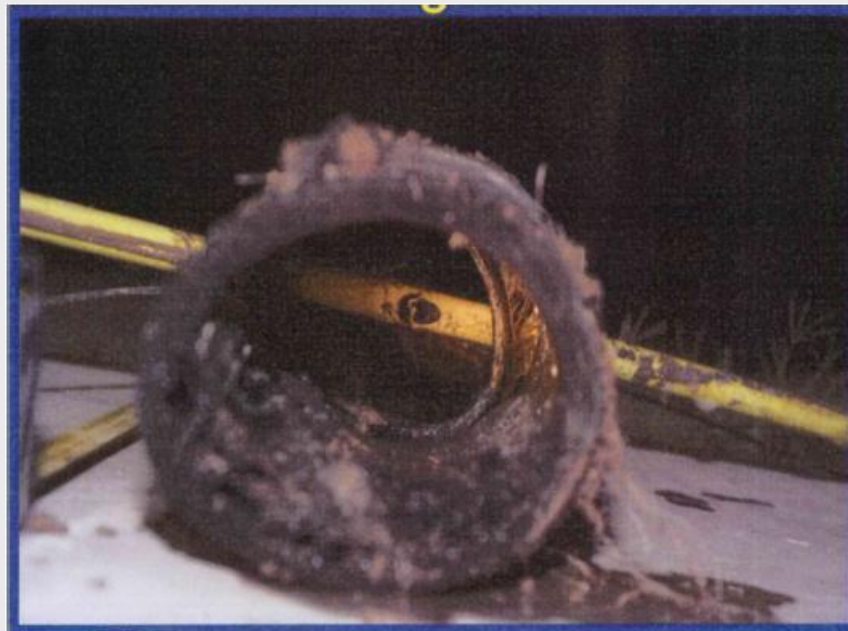
Gas Explosion

Mobile Home Destroyed, 3 Injured

The sewer pipe eventually became obstructed. A maintenance man attempted to clear the sewer lateral with an auger and broke the gas line.

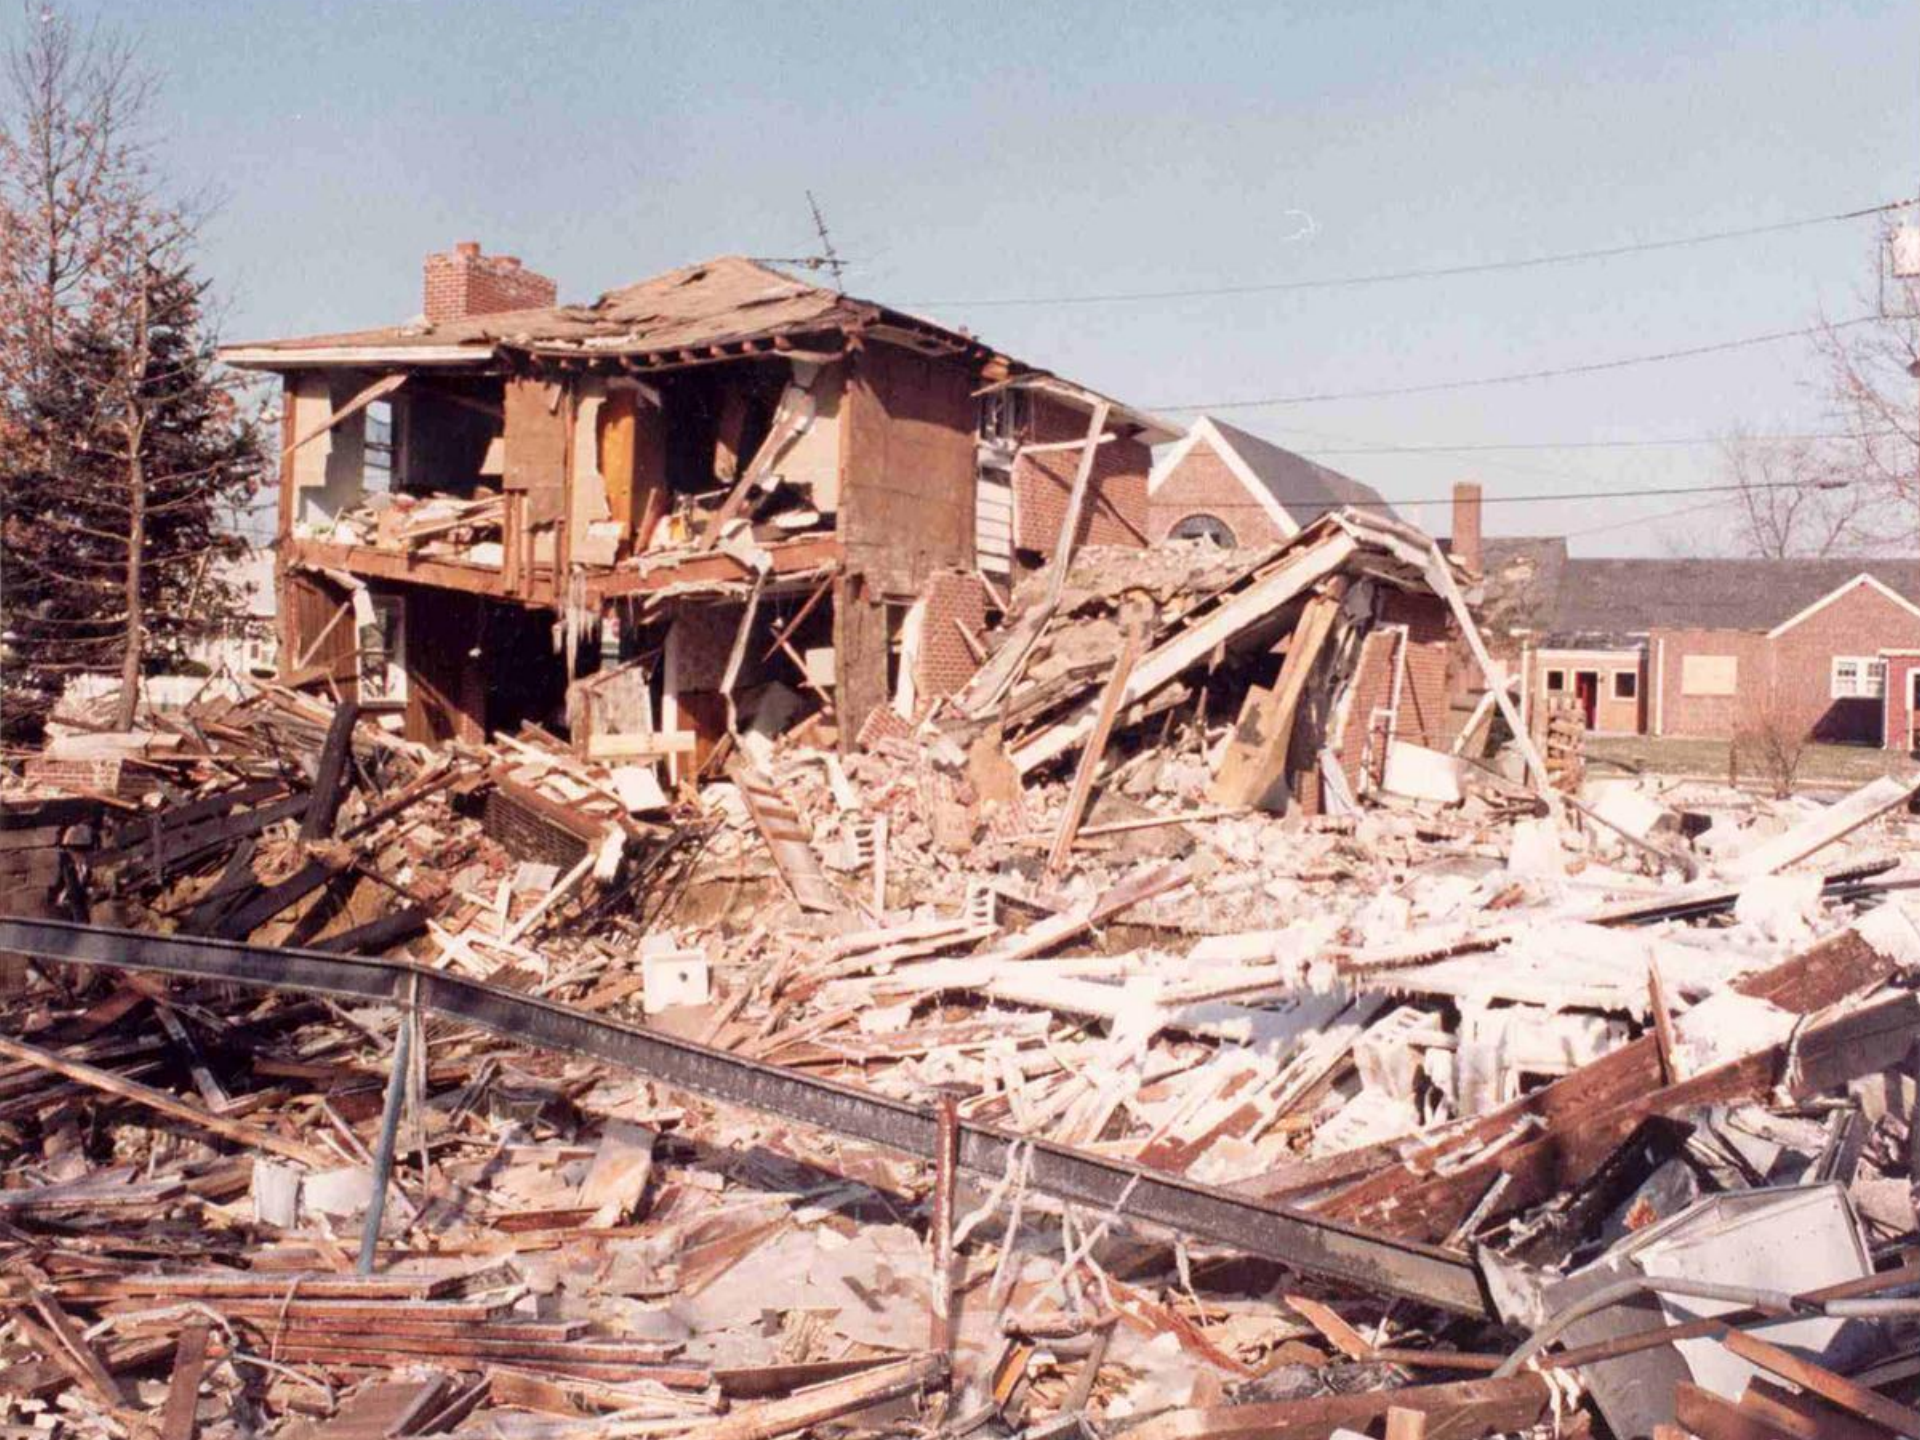
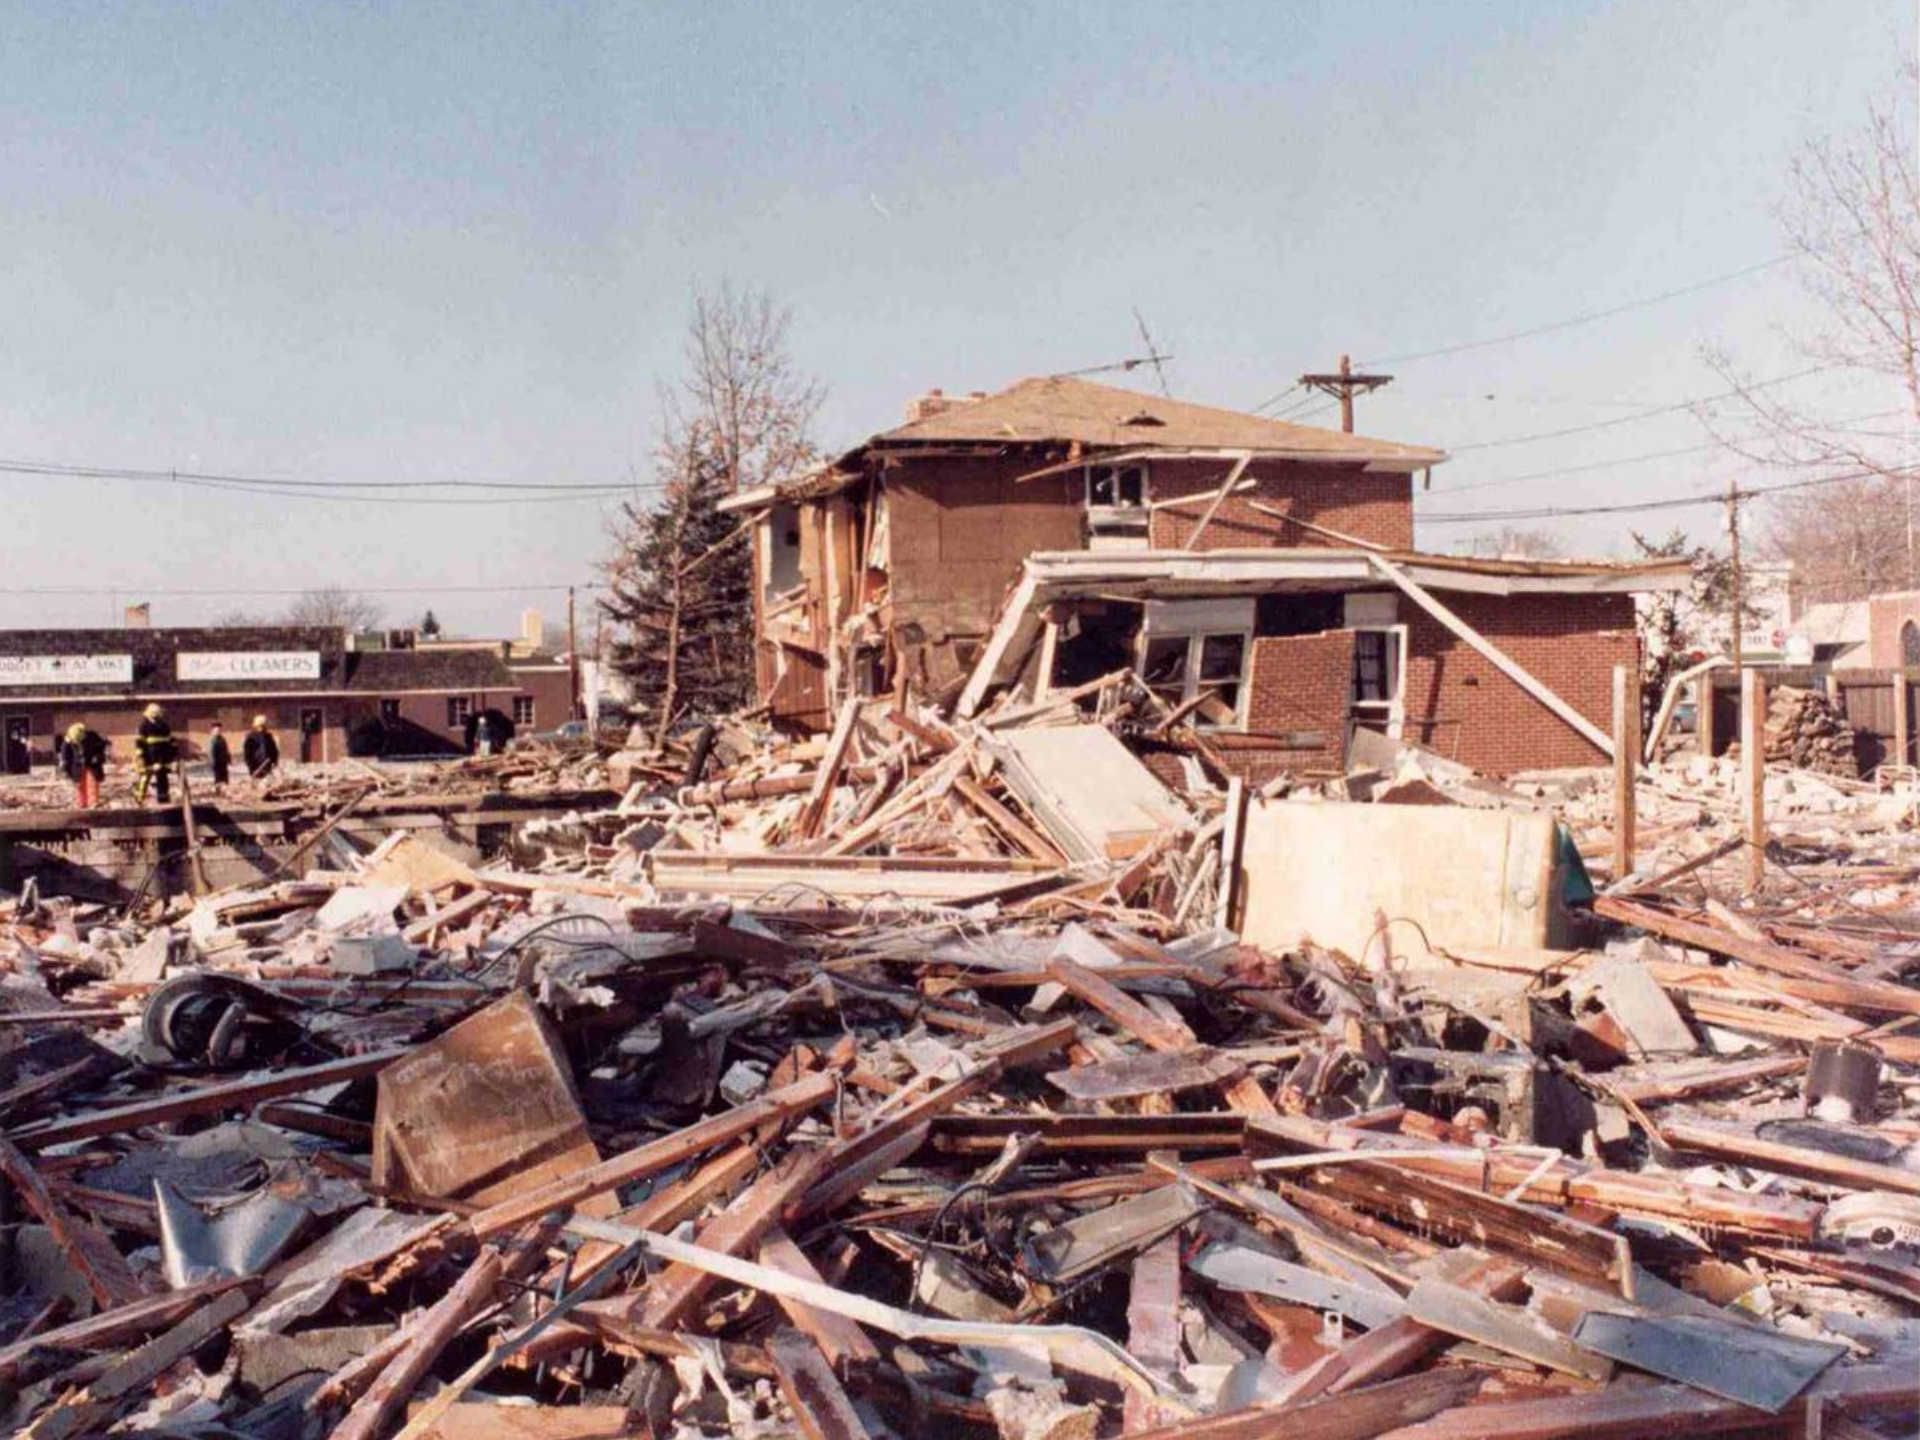
Gas Explosion Mobile Home Destroyed, 3 Injured

- Natural gas flowed within the sewer lateral, traveled into the plaintiffs' mobile home where there was an explosion and fire. Three people suffered serious burn injuries.
 - Contractor was told that sewer laterals ran parallel to the bore path and were not marked.
